Hartman Home Inspections

SUMMARY INSPECTION REPORT

Inspection Address: 18920 4th Ave S, Burien, Washington 98148

Inspection Date: 8/28/2019 Start: 10:00 am End: 12:30 pm

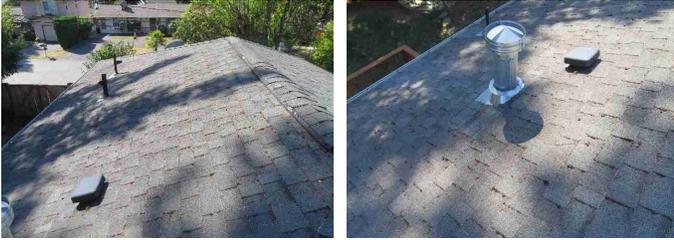
3.1 - The roof is in the primary stages of decomposition, which means that the roof is in decline and susceptible to leaks. It will need to be maintained and closely monitored, because it is reaching the end of its serviceable life, and you may wish to have a second opinion from a roofing contractor.

The roof is in the primary stages of decomposition and should be monitored more closely - *Continued*

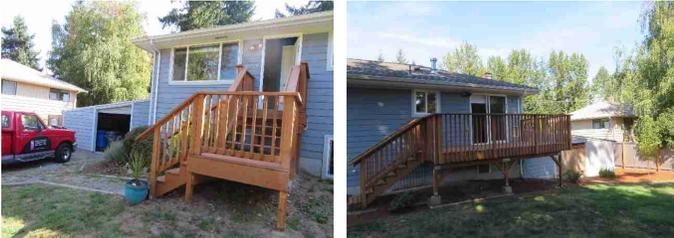
The wood deck and front porch are in serviceable condition.

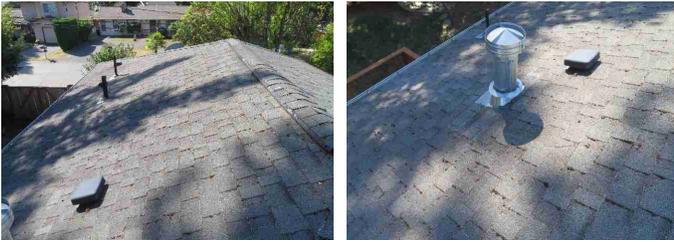
The roof is in the primary stages of decomposition, which means that the roof is in decline and susceptible to leaks. It will need to be maintained and closely monitored, because it is reaching the end of its serviceable life, and you may wish to have a second opinion from a roofing contractor.

The roof is in the primary stages of decomposition and should be monitored more closely - *Continued*

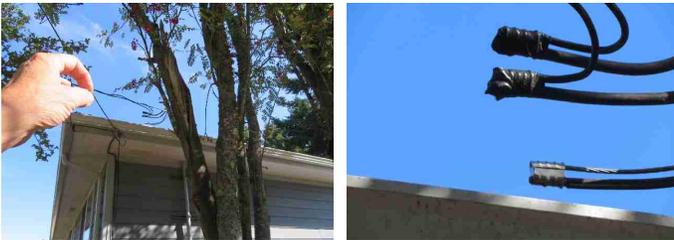
The service entrance, mast weather head, and cleat are in acceptable condition. The connection is incomplete (see below).

The service entrance conductor line connection is incomplete. A permanent connection should be done by an electrician. Service is recommended.

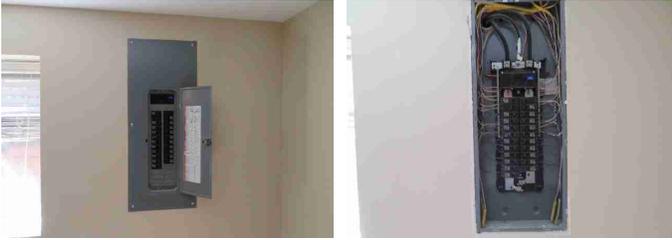
The residence is served by a 200 amp, 220 volt panel, located in the basement of the residence.

The main panel is located in the basement of the residence - *Continued*
