Hartman Home Inspections

SUMMARY INSPECTION REPORT

Client: Vi Nguyen
Inspection Address: 10046 3rd Ave SW, Seattle, Washington 98146
Inspection Date: 10/5/2019 Start: 10:30 am End: 12:30 pm
Inspected by: Don Hartman, Licensed Home Inspector #292

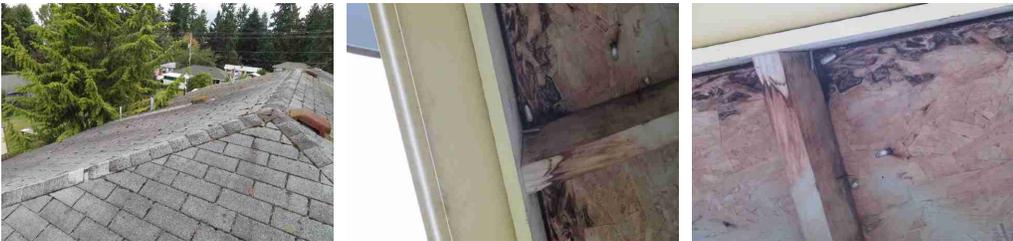
- 3.1 - The roofing material is deteriorated and should be evaluated by a roofing contractor for replacement estimates. No leaks were observed other than the rear bump out soffit that appears to leak or was leaking.

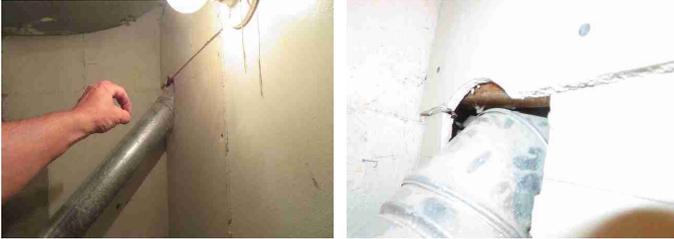
6.2 - The vent pipe is too close to combustible material, and should be serviced. A single-walled vent pipe should be six inches away from any combustible material, and a double-walled vent pipe should be one inch away.

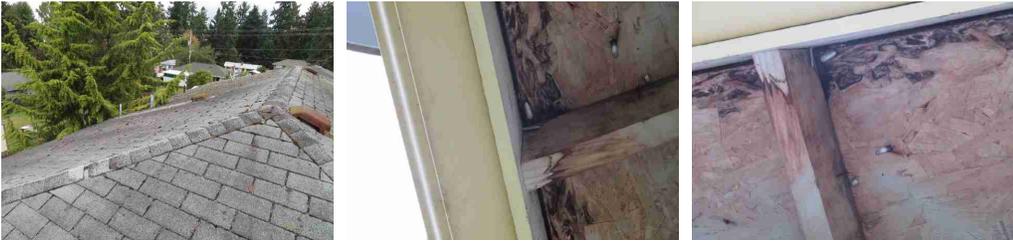
The roofing material is deteriorated and should be evaluated by a roofing contractor for replacement estimates. No leaks were observed other than the rear bump out soffit that appears to leak or was leaking.

The roofing material is deteriorated and should be evaluated by a roofing contractor - *Continued*

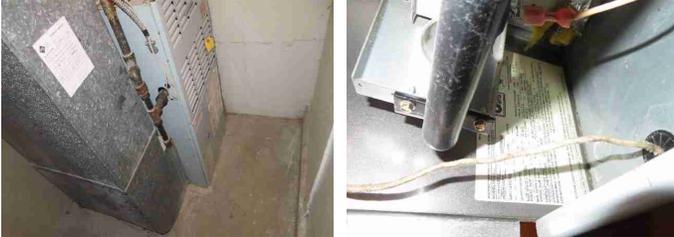
Unprotected romex wire at the furnace should be in the proper conduit.

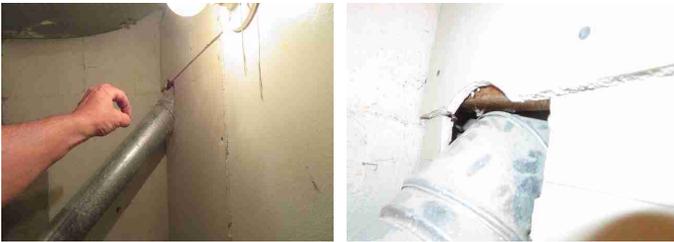
The vent pipe is too close to combustible material, and should be serviced. A single-walled vent pipe should be six inches away from any combustible material, and a double-walled vent pipe should be one inch away.
