# Hartman Home Inspections

## SUMMARY INSPECTION REPORT

**Client:** Jeff Hsu  
**Inspection Address:** 5420 Renton Ave S, Seattle, Washington 98118  
**Inspection Date:** 5/13/2020 Start: 1:00 pm End: 3:00 pm  
**Inspected by:** Don Hartman, Licensed Home Inspector #292

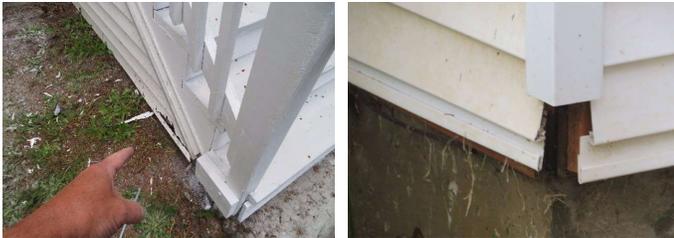
- 1.1 - There are a couple of areas where the vinyl has been damaged, likely due to a weeder or mower. They can be replaced.

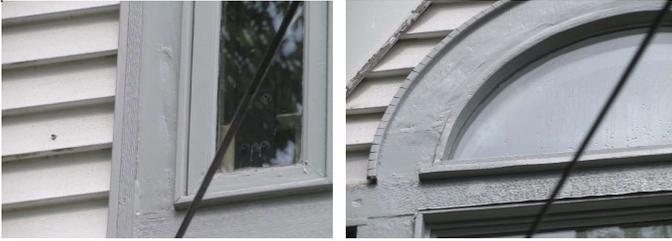
There is rot or soft wood that was painted over - *Continued*

- 1.2 - There is rot or soft wood that was painted over. Rot was observed at sections of the trim on primarily the left side gable window trim. The trim was recently painted, therefore I did not probe the trim to confirm. Rotted or soft wood should be identified and replaced. The trim on the dwelling was mostly clad in metal when the vinyl siding was replaced. The condition of the trim under the metal cladding could not be determined and is excluded from the inspection.

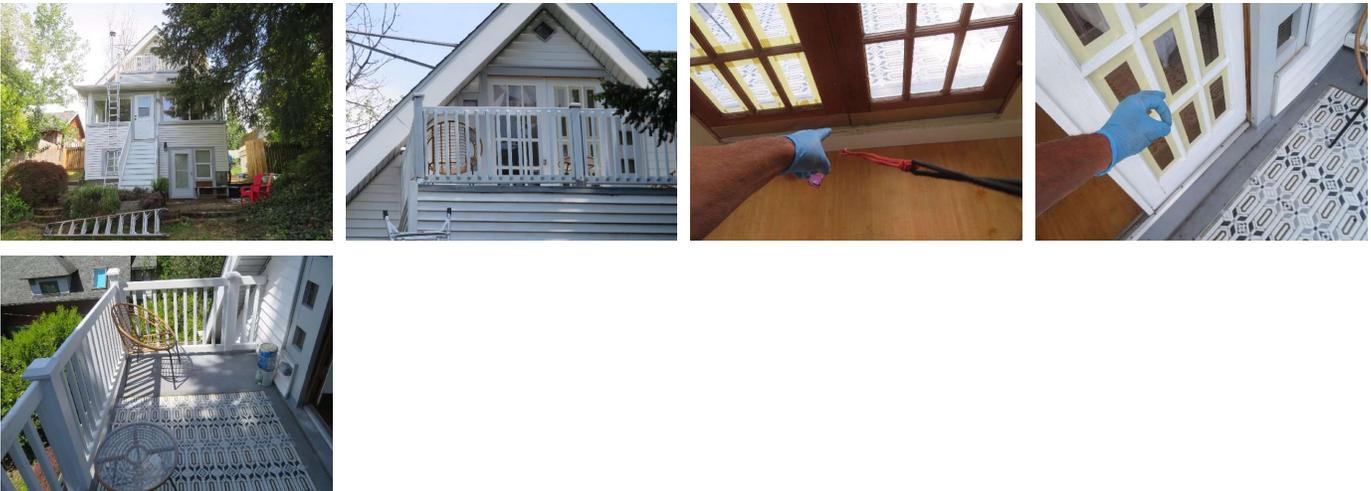
1.3 - The roof top deck pictured is unorthodox. It is doubtful that this was a permitted project. The project would have required a permit. My concern is the coated deck and door to the master bedroom leaking during wind driven rain. Ideally a more weather proof door would be installed and a membrane type deck should be considered. Please call me if you have additional questions regarding the deck.

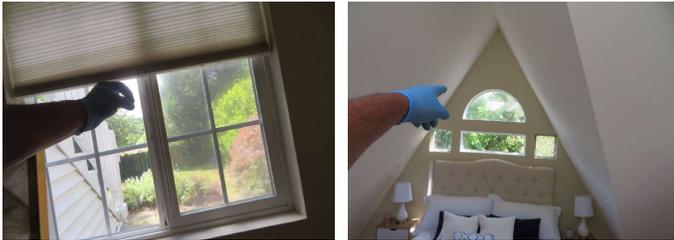
9.2 - One or more windows have broken hermetic seals and should be replaced. This is evident from fogging, or condensation forming between the panes of glass, that confirm that the seal has failed. Due to weather variations, there may be additional broken seals that we could not see at the time of the inspection. Example pictured. I observed that the windows are Milguard brand and failed seals may be covered under warranty. Follow up is recommended.

One or more windows have broken hermetic seals and should be replaced. This is evident from fogging, or condensation forming between the panes of glass, that confirm that the seal has failed. Due to weather variations, there may be additional broken seals that we could not see at the time of the inspection. Example pictured. I observed that the windows are Milguard brand and failed seals may be covered under warranty. Follow up is recommended.

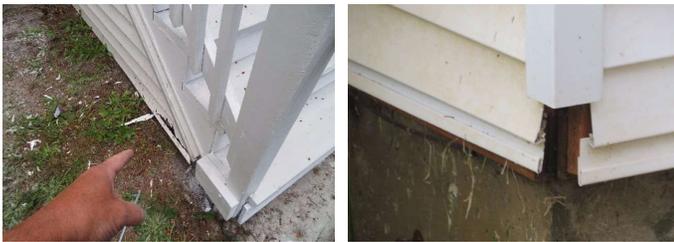
There are a couple of areas where the vinyl has been damaged, likely due to a weeder or mower. They can be replaced.

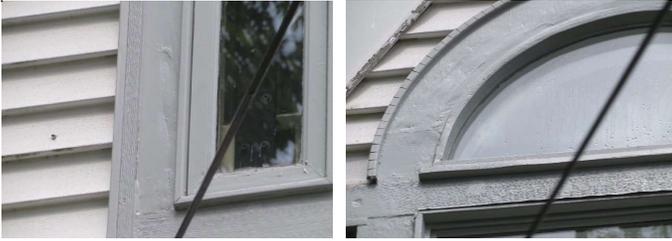
There is rot or soft wood that was painted over - *Continued*

There is rot or soft wood that was painted over. Rot was observed at sections of the trim on primarily the left side gable window trim. The trim was recently painted, therefore I did not probe the trim to confirm. Rotted or soft wood should be identified and replaced. The trim on the dwelling was mostly clad in metal when the vinyl siding was replaced. The condition of the trim under the metal cladding could not be determined and is excluded from the inspection.

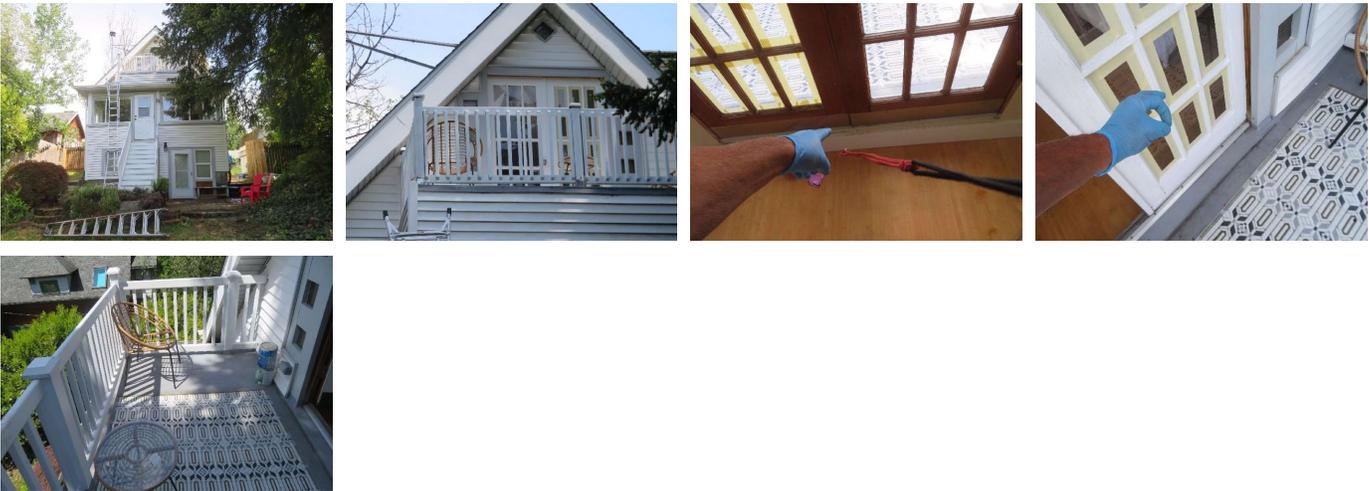
The roof top deck pictured is unorthodox. It is doubtful that this was a permitted project. The project would have required a permit. My concern is the coated deck and door to the master bedroom leaking during wind driven rain. Ideally a more weather proof door would be installed and a membrane type deck should be considered. Please call me if you have additional questions regarding the deck.

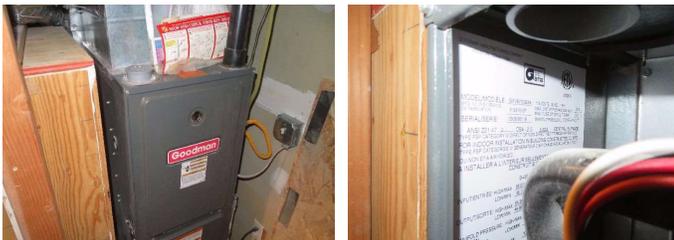
Central heat is provided by a gas forced air furnace. The appliance is fifteen years' old and located in the basement.

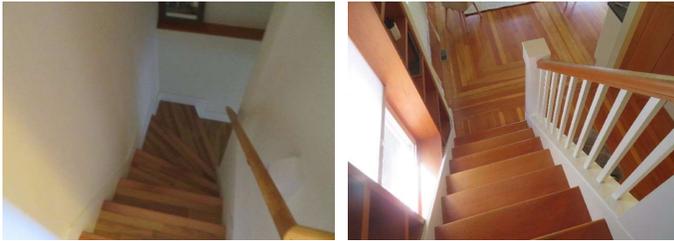
We have evaluated the stairs and landing, and found them to be in acceptable condition.

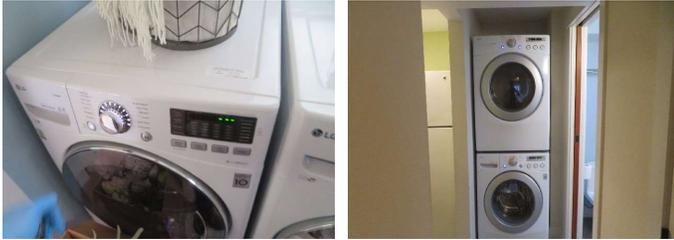
Two sets of connected washers and dryers are present but were not fully tested. The appliances are connected and respond to the controls but were not fully tested. I did not wash or dry clothes to confirm full functionality.
